HISTORIC PRESERVATION COMMISSION

March 14, 2016

Evaluation of Exterior Walls and Roofs at Batavia Park District East Side Community Center Complex

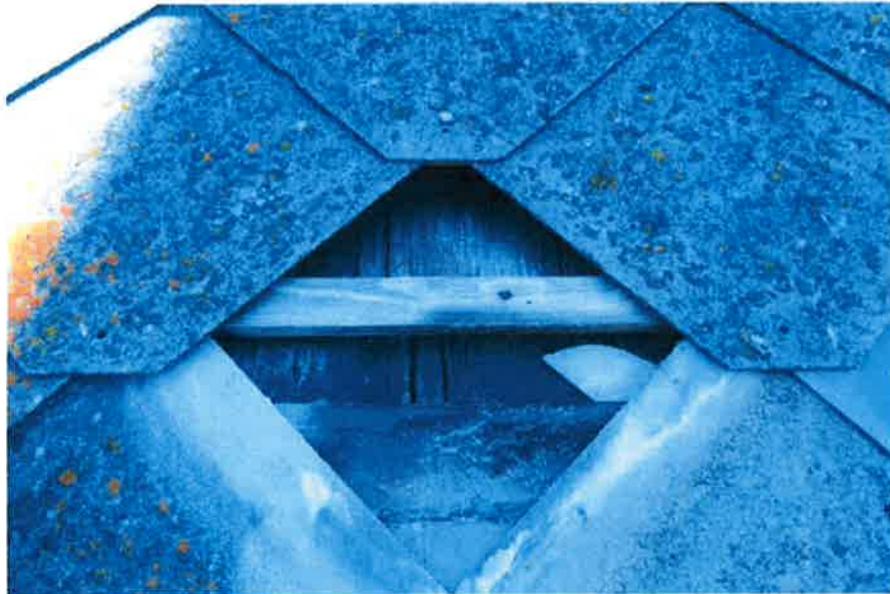
1. Loose and/or missing shingles were observed at several locations (Photo 1).
2. Exposed nails were loose at several locations (Photo 2). Typically, nails should be concealed below the adjacent upper row of shingles.

Photo 1 – Loose and/or missing shingles were observed at several locations.

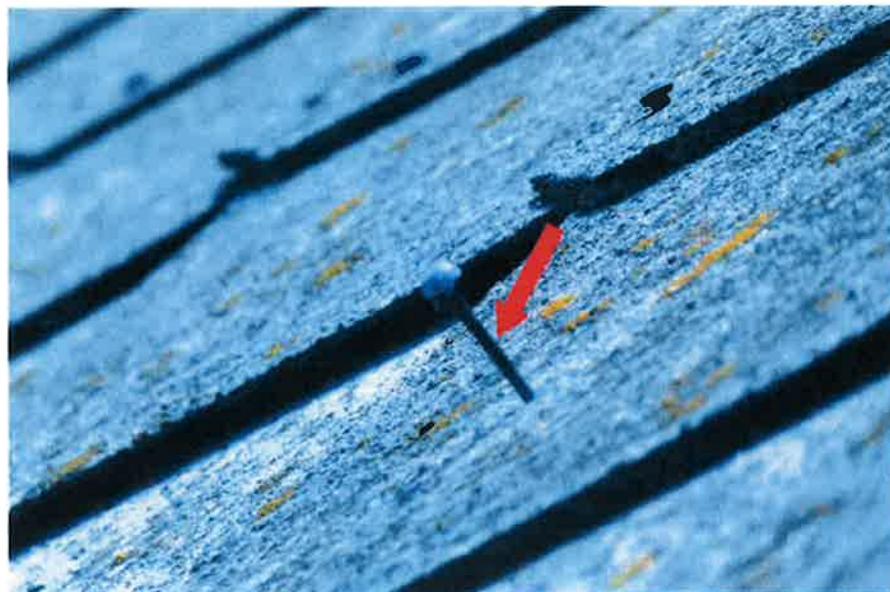
Photo 2 – Exposed nails were loose at several locations.

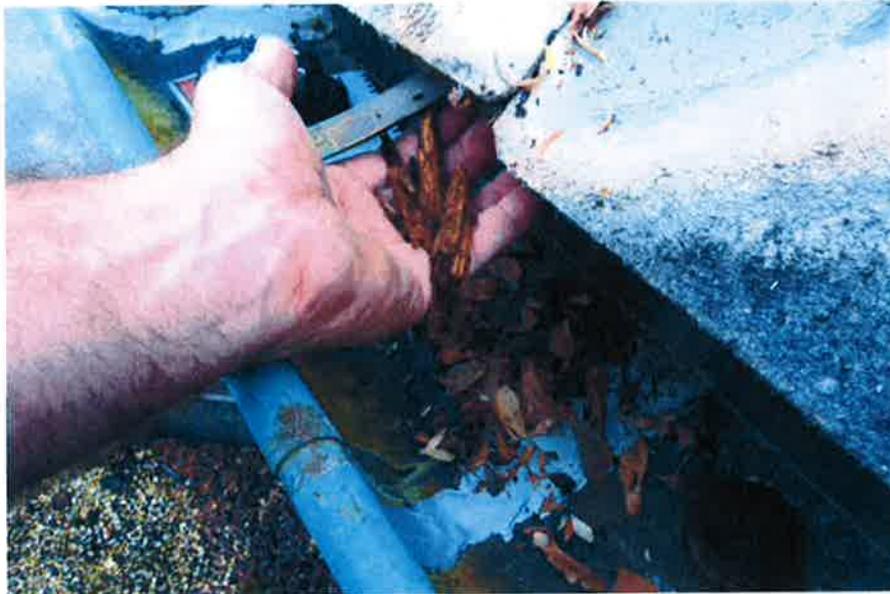
3. Where accessible during our evaluation, underlying wood components exhibited deterioration along roof edges (Photo 3). Based on the age and deterioration of the roofing system components, we suspect that underlying wood components exhibit deterioration at many other locations on the roof.

Photo 3 – Underlying wood components exhibited deterioration along roof edges.

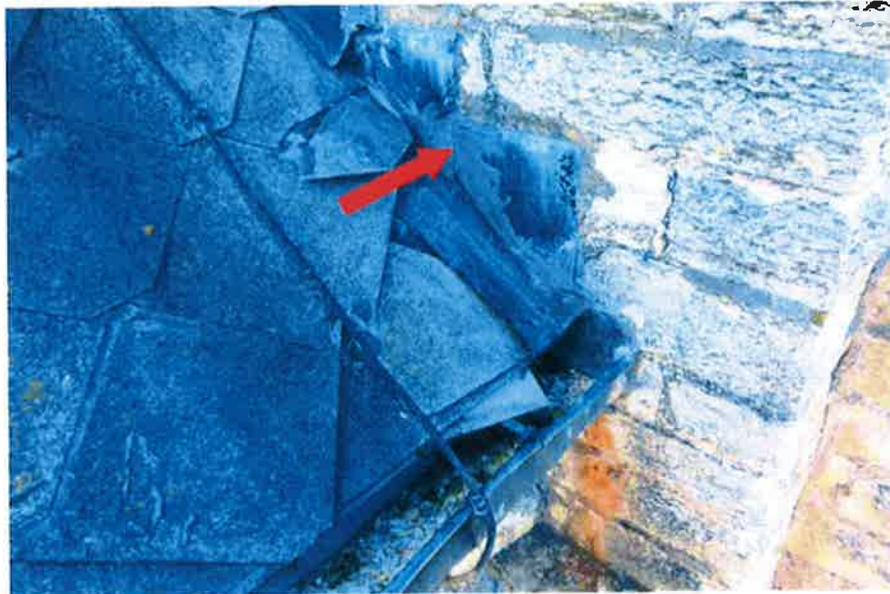
4. At several locations on and near roof flashings, repairs consisted of an application of roof cement (Photo 4). Such repairs are considered to be temporary until more durable long-term repairs can be implemented.

Photo 4 – At several locations on and near roof flashings, repairs consisted of an application of roof cement.

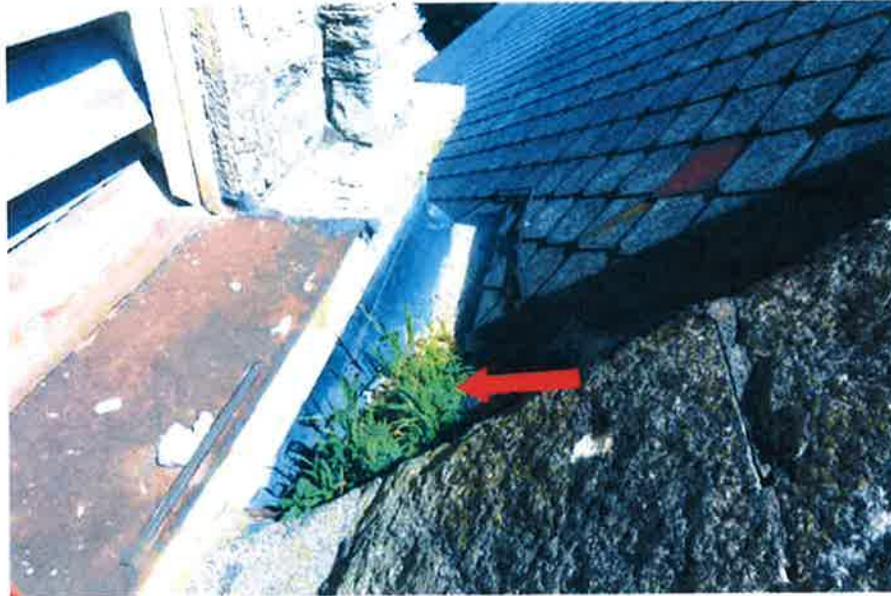
5. A large area of vegetation was observed on the roof along the east side of the bell tower (Photo 5). Roof drainage/slope at this location was insufficient to promote drainage around the bell tower.

Photo 5 – A large area of vegetation was observed on the roof along the east side of the bell tower.

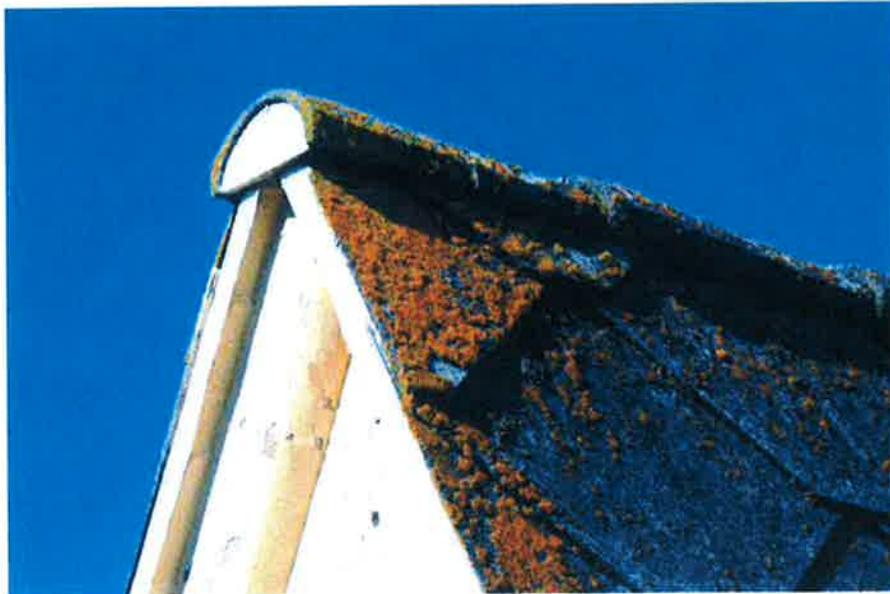
Photo 6 – Biological growth was observed on shingle surfaces at several locations.

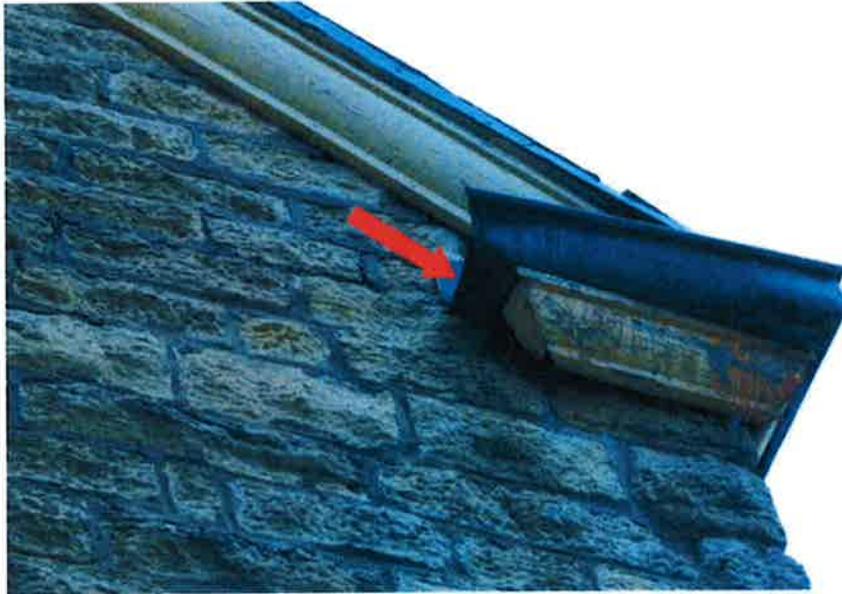
Photo 7 – At 1 location, a gutter terminated without the use of a downspout.

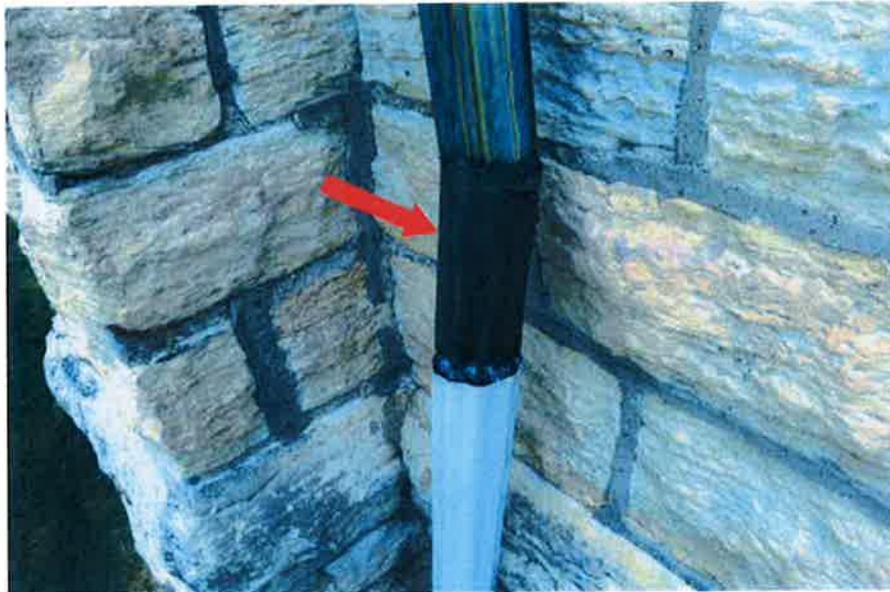
Photo 8 – Previous downspout and gutter repairs had not been properly implemented at several locations.

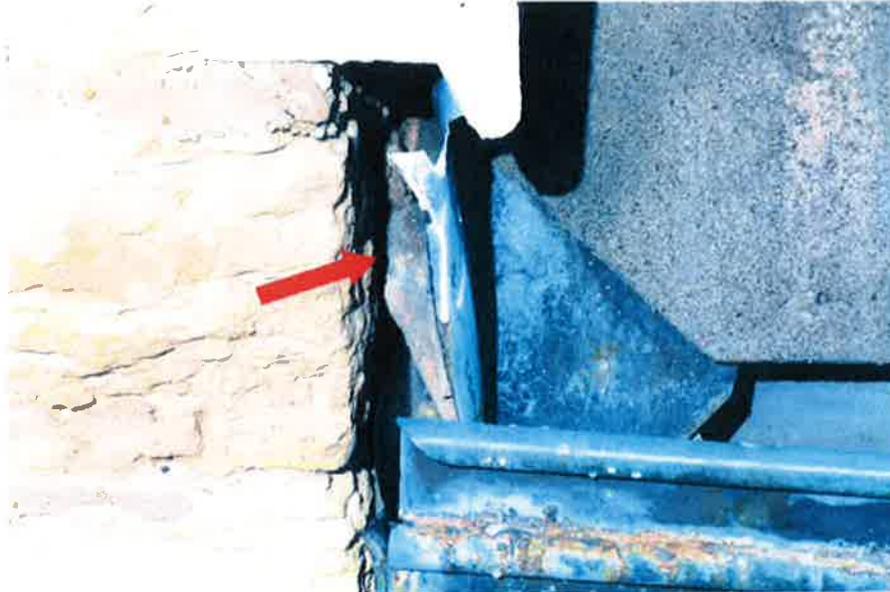
Photo 9 – The intersection between the roof, exterior wall, and gutter end cap was open at 1 location.

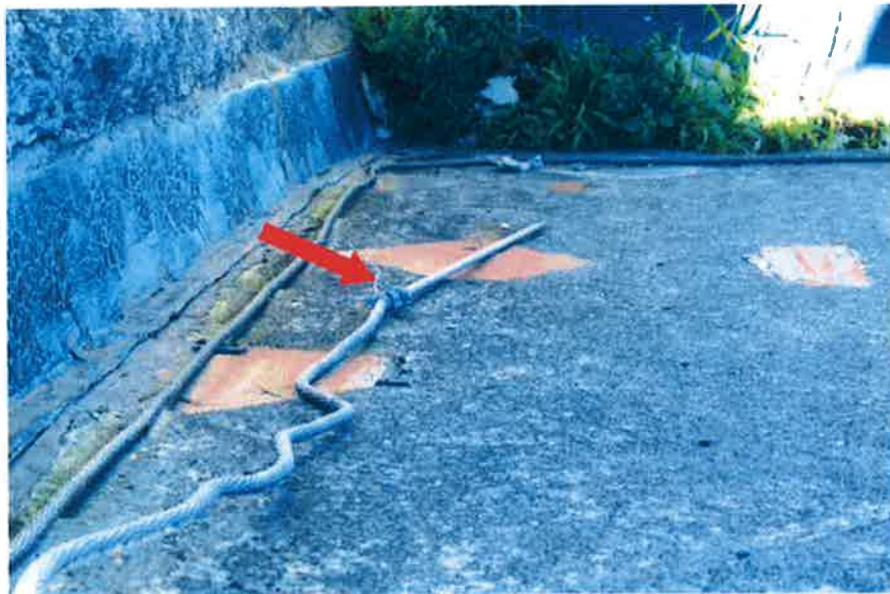
Photo 10 – A lightning arrest system had been installed on the roof. However, this system was not properly affixed to the roof to protect the building from lightning.

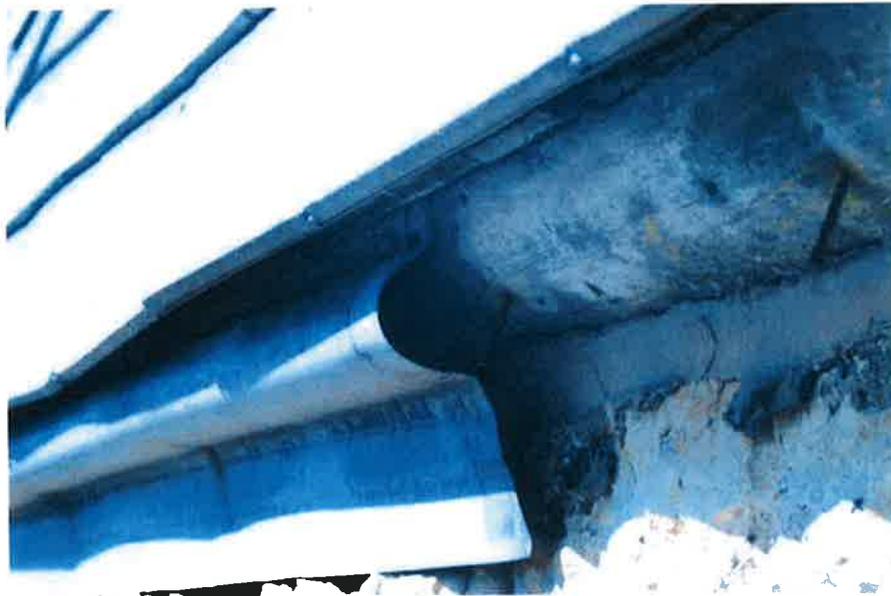
Photo 12 – Counterflashing concealing original wood trim around the base of the roofing system had detached at 1 location.

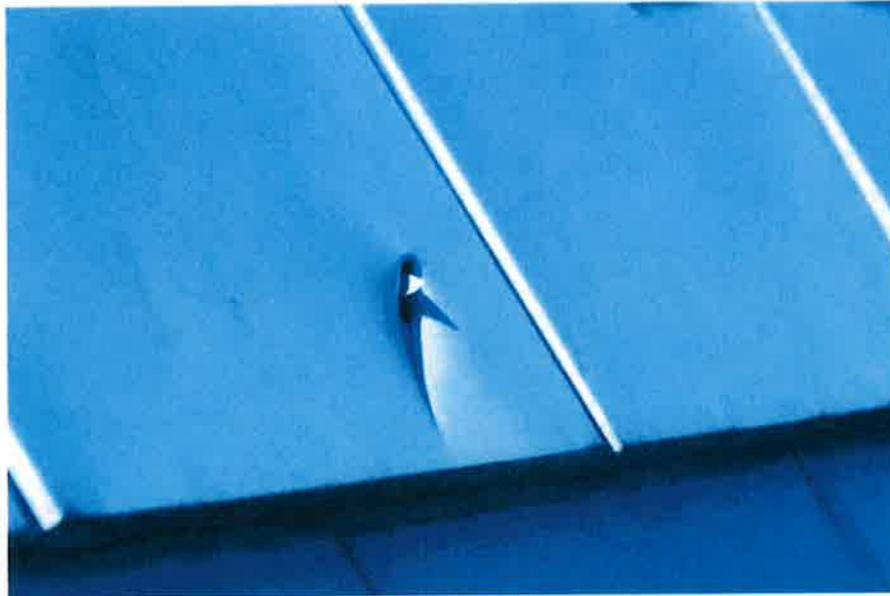
Photo 13 – Gashes through the aluminum shingles were observed at a few locations.

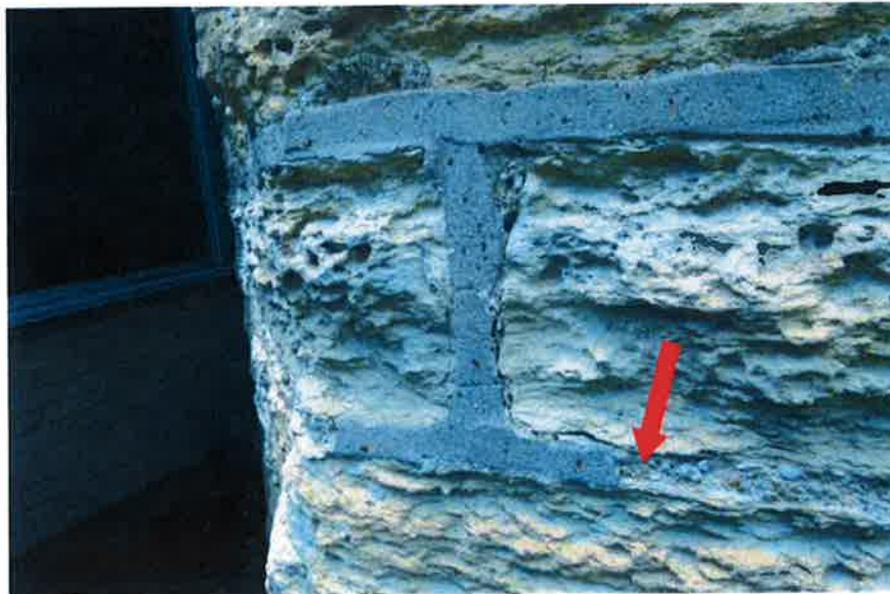
1. Masonry mortar joints were generally in poor condition. Observations specific to the mortar joints included the following:
 - a. At many locations, mortar joints had been improperly repointed by applying a thin layer of new mortar over existing mortar. This mortar has de-bonded at many locations (Photo 14).

Photo 14 – At many locations, mortar joints had been improperly repointed by applying a thin layer of new mortar over existing mortar. This mortar has de-bonded at many locations.

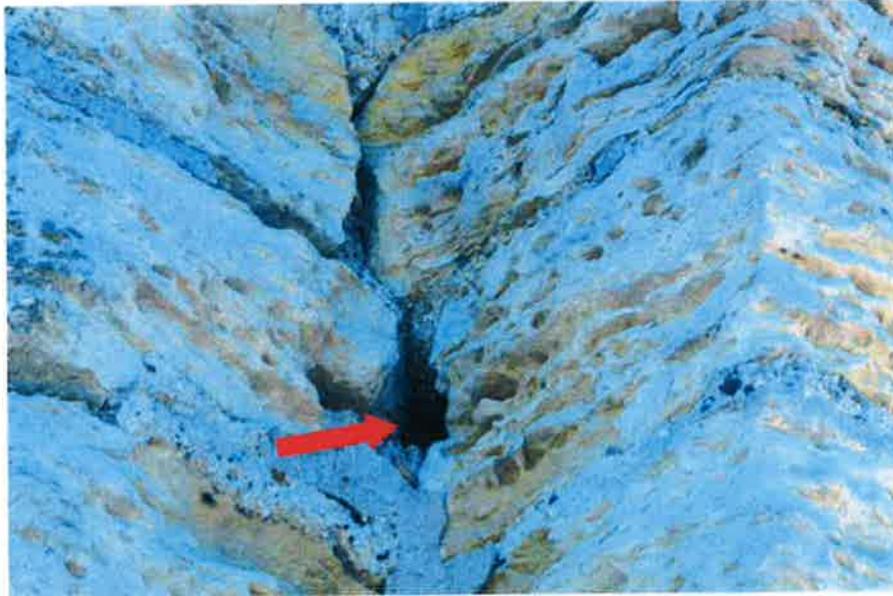
Photo 15 – Many mortar joints were open or partially open on the exterior of the building.

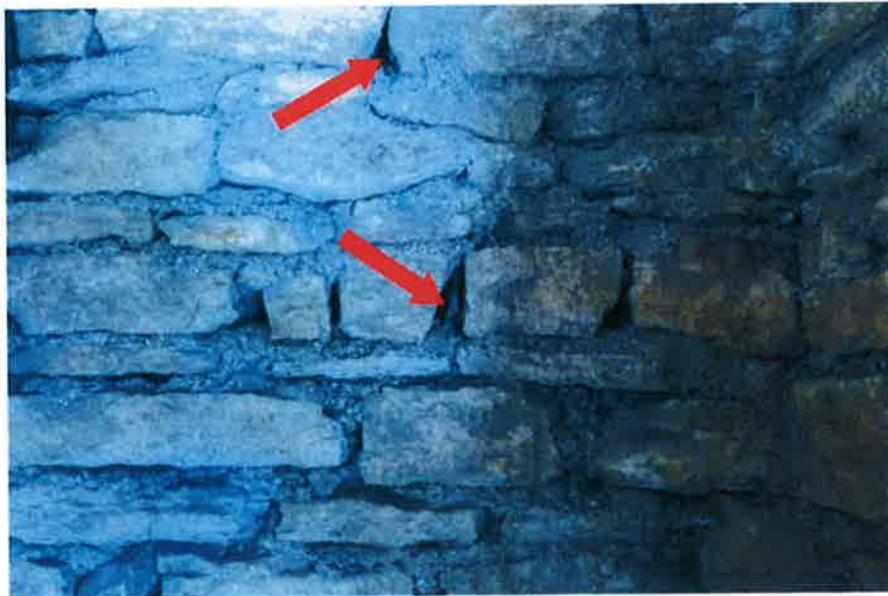
Photo 16 – Several mortar joints were also observed to be open or partially open on the interior side of the bell tower walls.

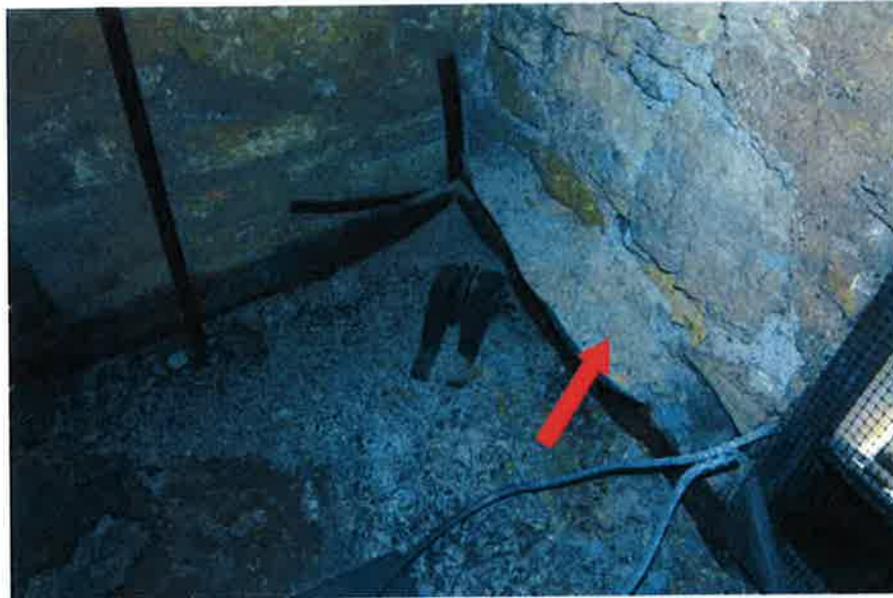
- c. Significant mortar deterioration was observed on the interior side of the exterior walls within the attic and on the interior side of the bell tower (Photo 17).

Photo 17 – Significant mortar deterioration was observed on the interior side of the exterior walls within the attic and on the interior side of the bell tower.

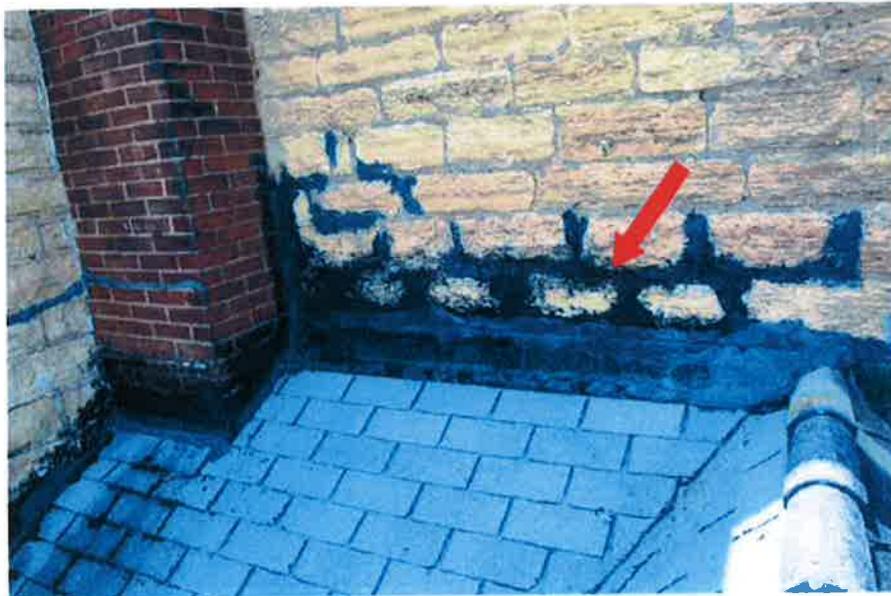
- d. Roof cement had been applied over mortar joints at a few locations (Photo 18). Such roof cement repairs are not considered suitable for exterior wall applications.

Photo 18 – Roof cement had been applied over mortar joints at a few locations.

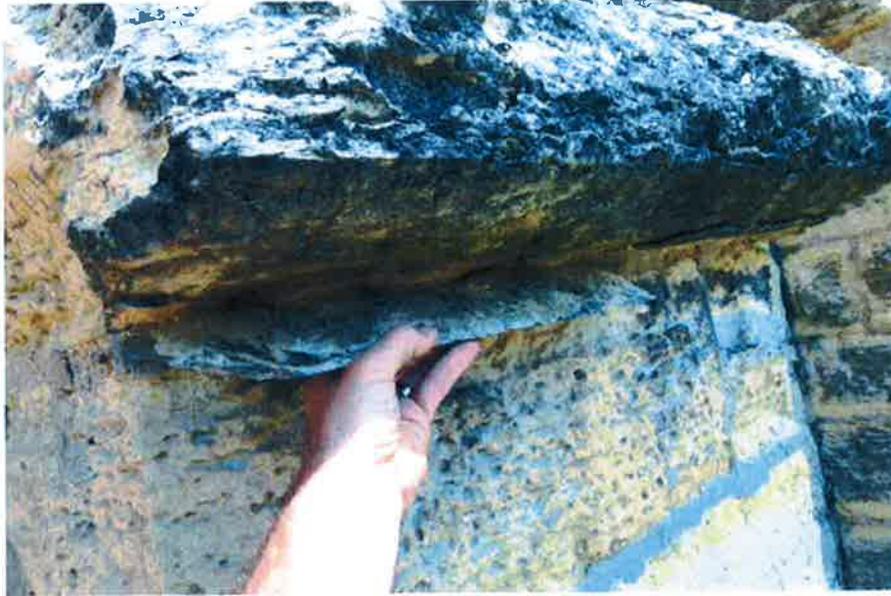
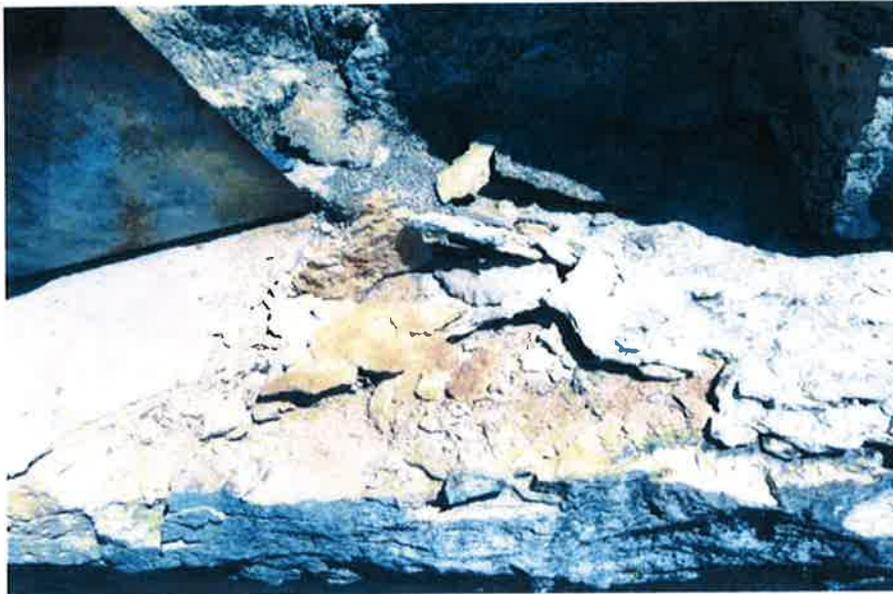
Photo 19 – Many limestone units exhibited flaking.

Photo 20 – Many limestone units exhibited flaking.

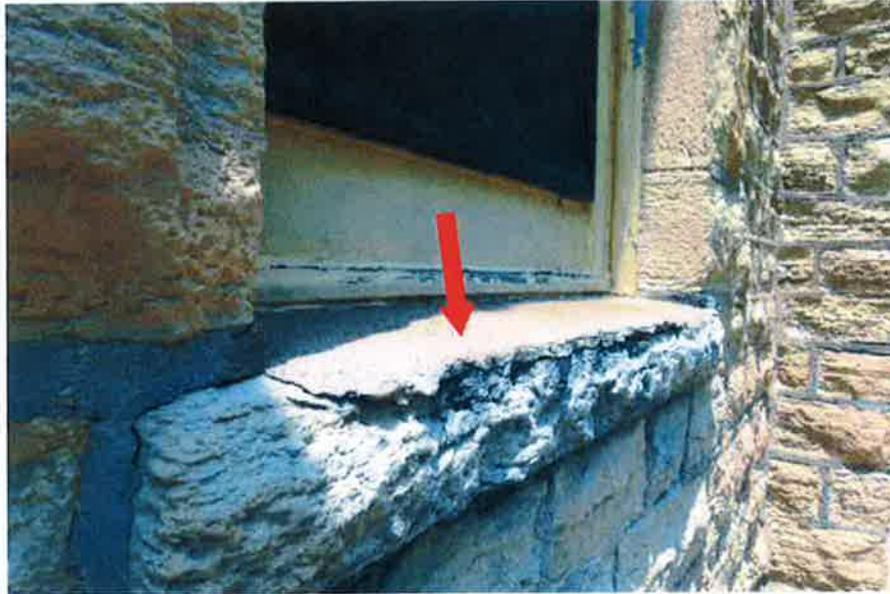
Photo 21 – At a few locations, a cementitious parge coat had been applied to top sides of limestone sills in an attempt to repair and/or conceal the flaking.

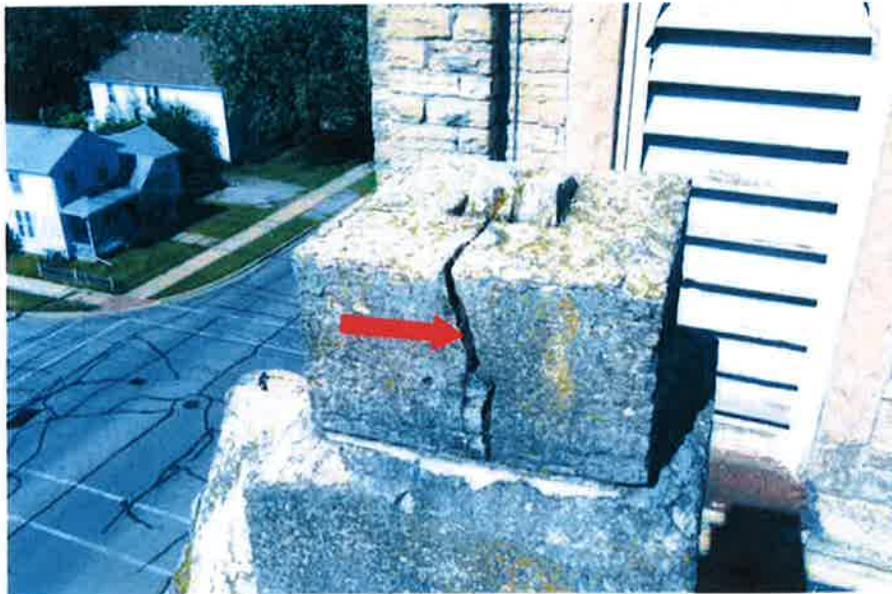
Photo 22 – Limestone cracking through the width of the unit was observed at a few locations.

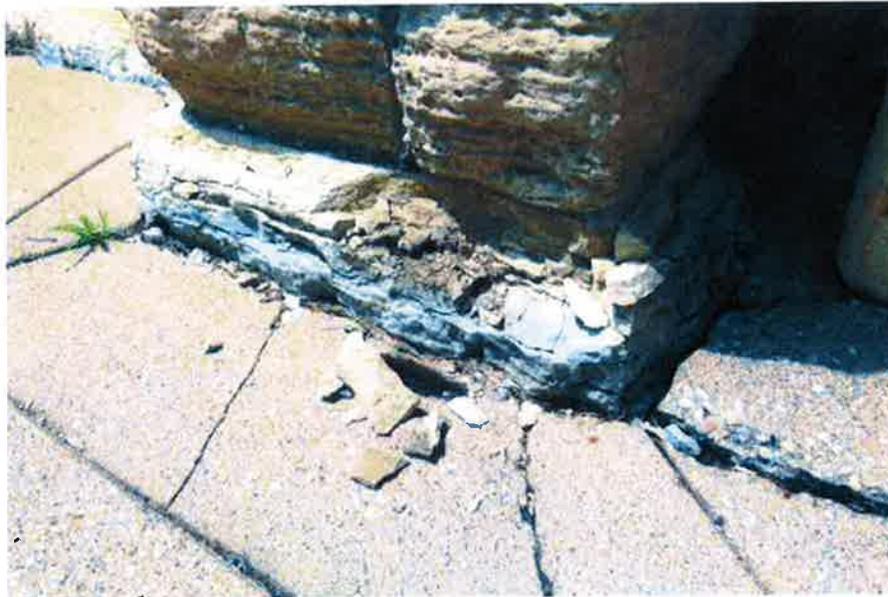
- b. Limestone cracking through the width of the unit was observed at a few locations (Photo 22).
 - c. Limestone units located near building entrances exhibited significant deterioration (Photo 23). This deterioration is attributed to the use of de-icing salts on the adjacent exterior walkways.

Photo 23 – Limestone units located near building entrances exhibited significant deterioration.

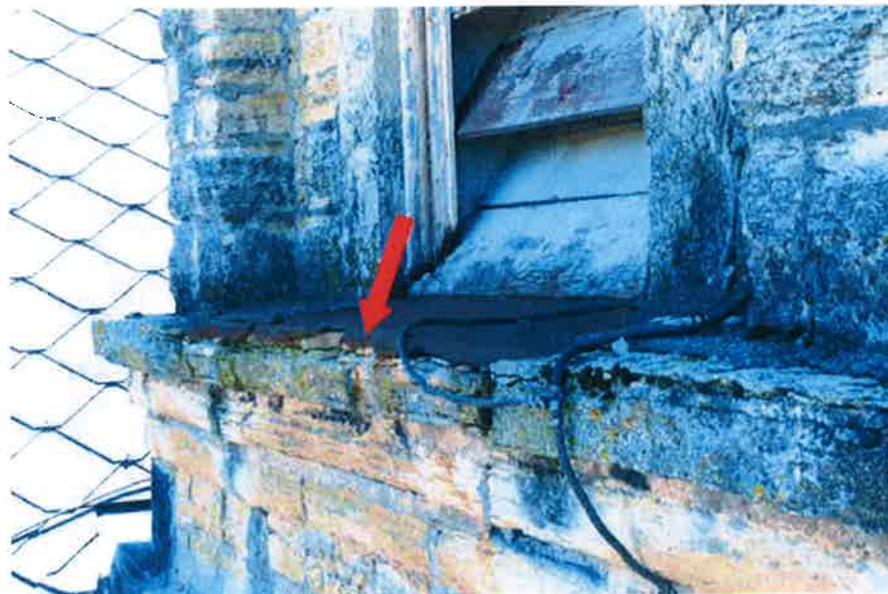
Photo 24 – Metal flashing extending over the ledges of the bell tower exhibited significant corrosion.

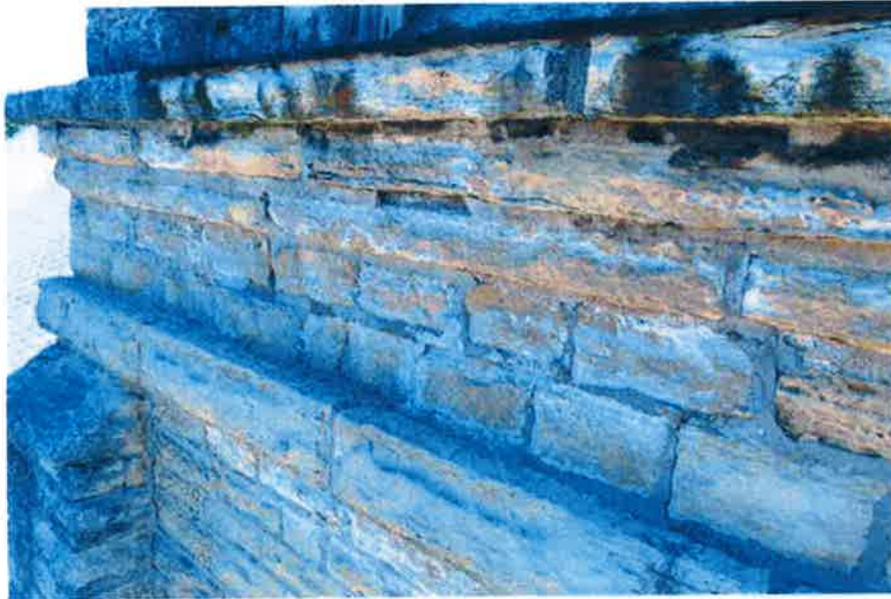
Photo 25 – Efflorescence was observed below the ledge on the west elevation of bell tower, indicating excessive water penetration.

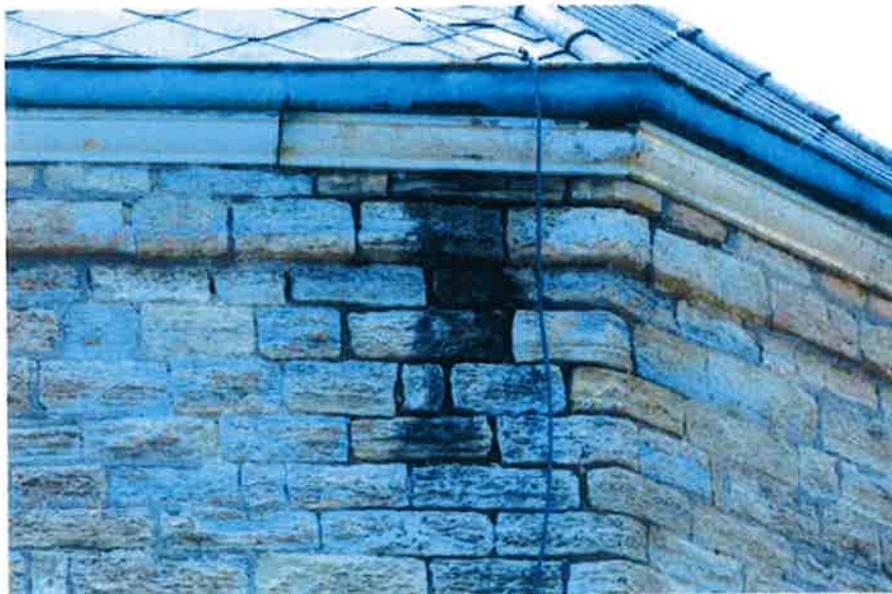
Photo 26 – Limestone exterior wall surfaces were damp and exhibited discoloration associated with prolonged water leakage on the north elevation.

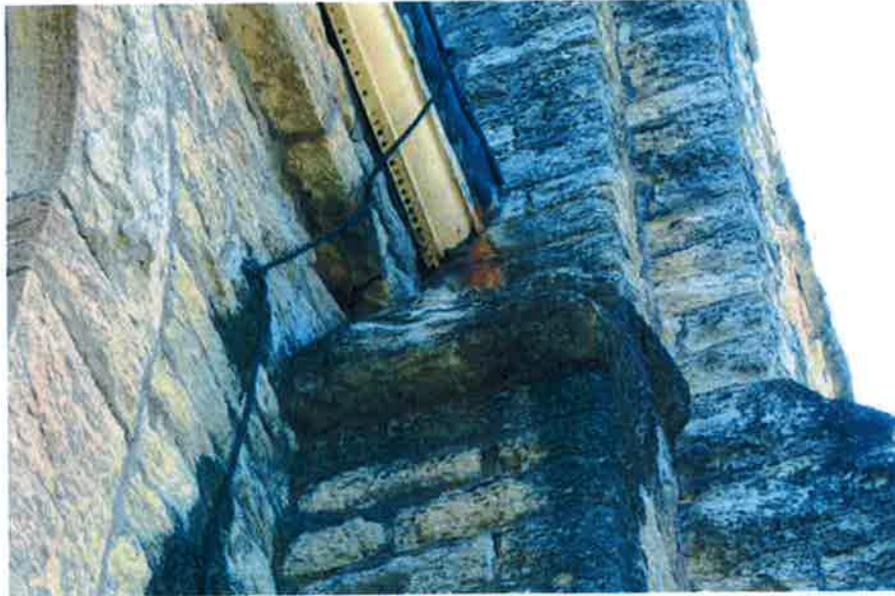
Photo 27 – Apparent biological growth was observed on exterior wall surfaces at several locations.

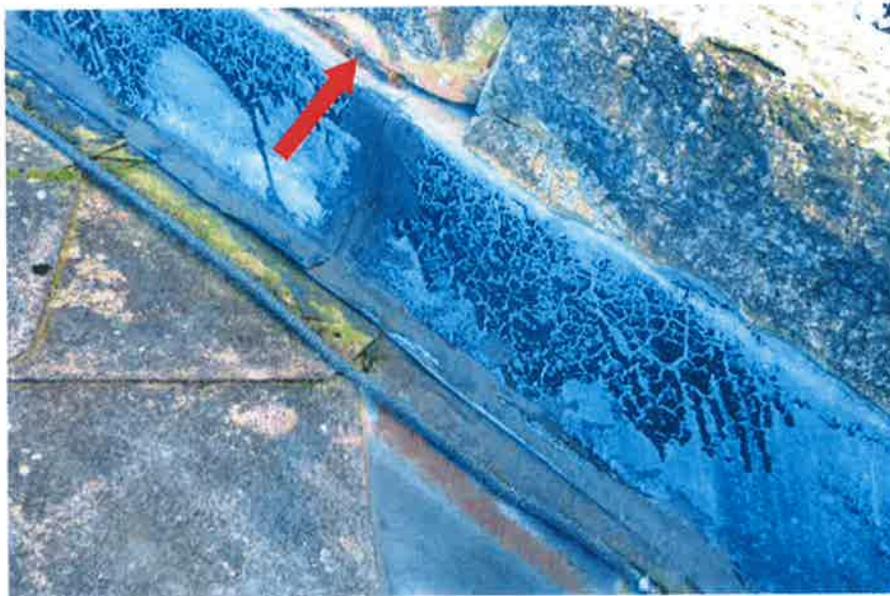
4. As observed along an open mortar joint, the copper counterflashing on the interior side of the gable wall along the south elevation did not extend below the full width of the copings to prevent water penetration (Photo 28).

Photo 28 – As observed along an open mortar joint, the copper counterflashing on the interior side of the gable wall did not extend below the full width of the copings to prevent water penetration.

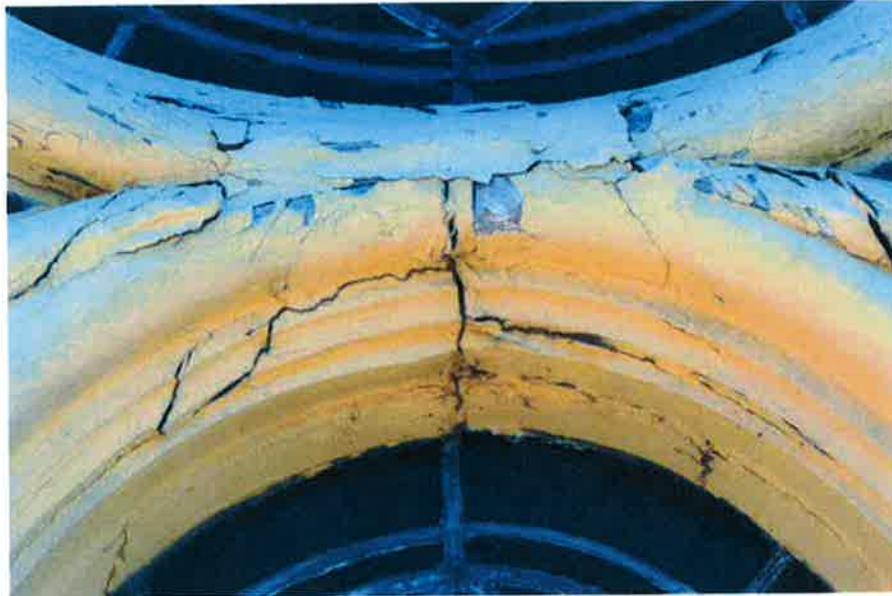
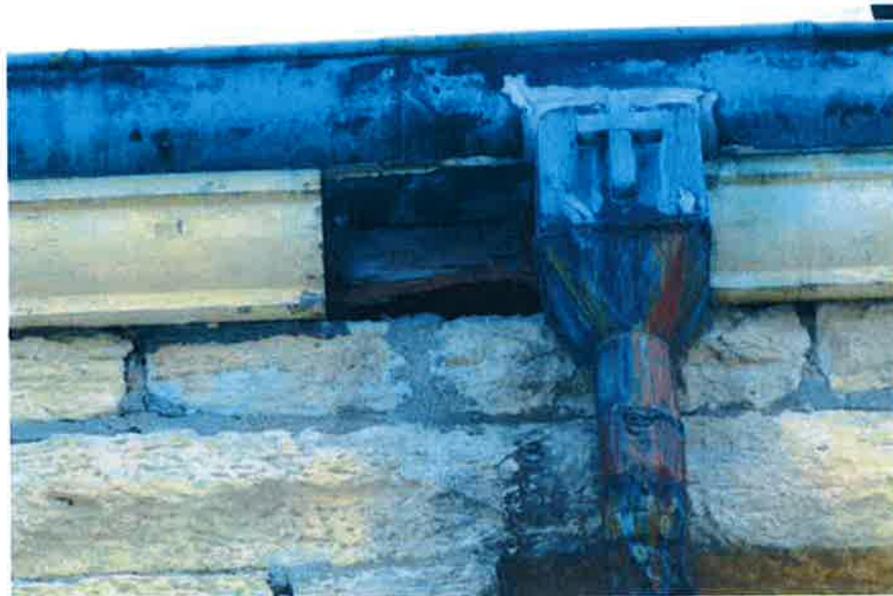
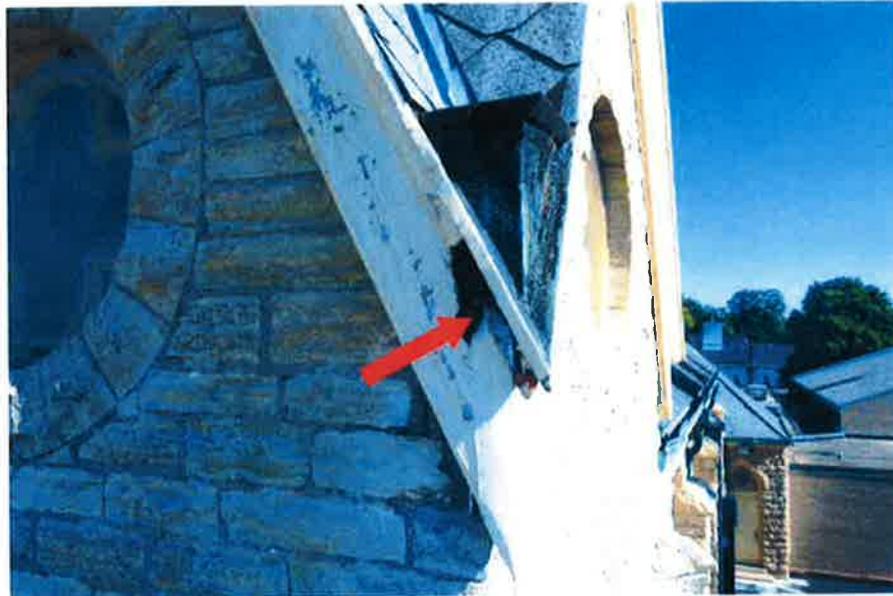
Photo 29 – Deterioration of wood window frames, door frames, louvers, and fascia trim was observed at many locations.

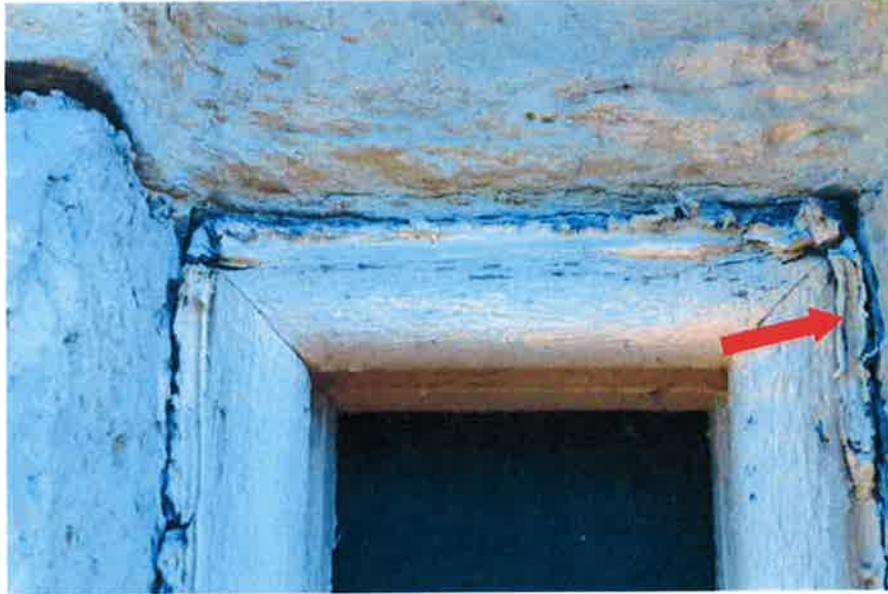
Photo 33 – Perimeter sealant joints around windows, doors, and louvers exhibited significant deterioration at most locations.

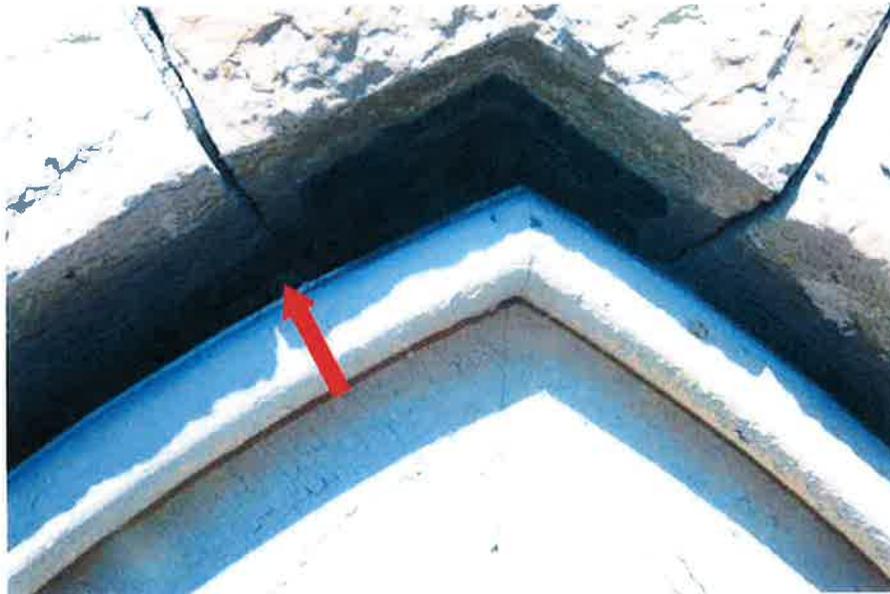
Photo 34 – At few locations, the perimeter joints were observed to be open.

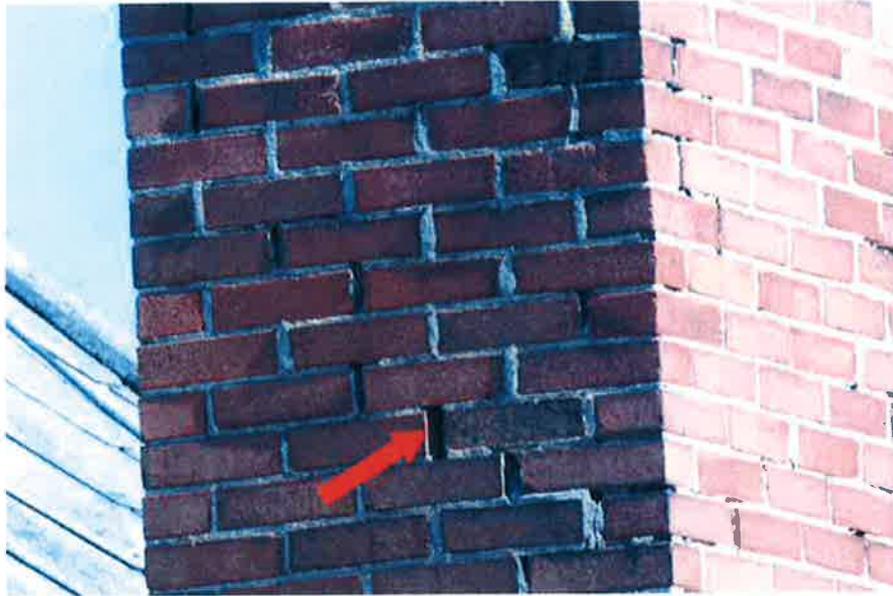
Photo 35 – Brick masonry mortar joints in the chimney on the east elevation of the building exhibited cracking.

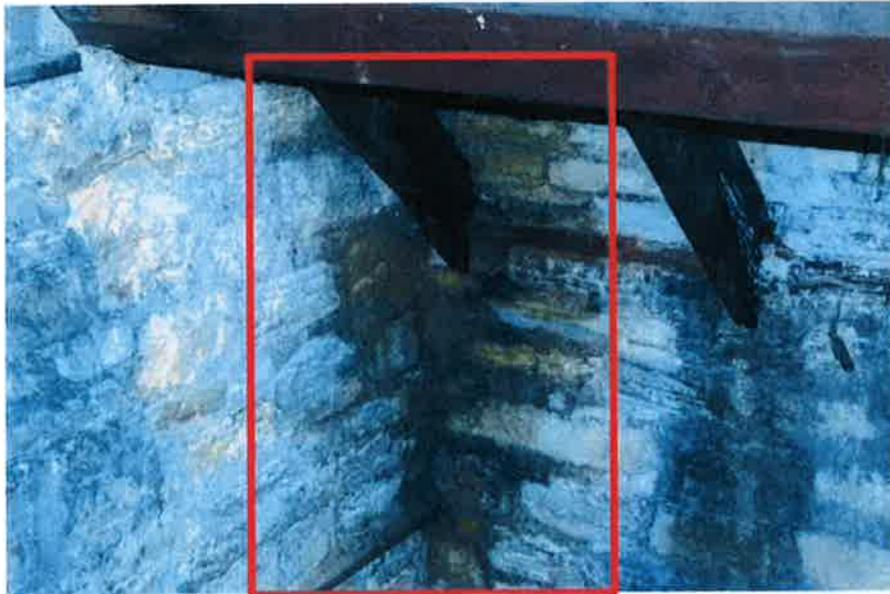
Photo 36 – Within the attic, the interior of the masonry wall was damp at the southeast corner of the bell tower, below the area where the south gable wall intersects the bell tower.

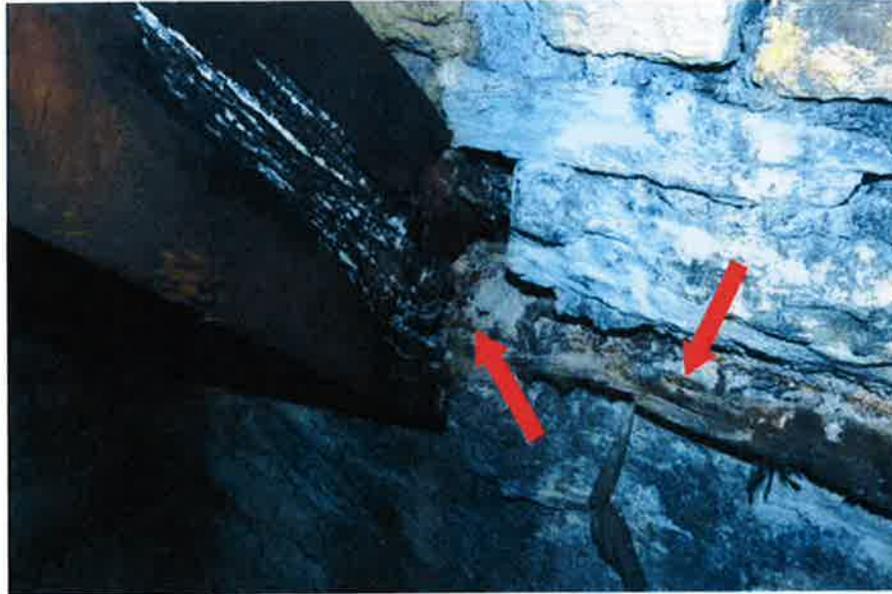
Photo 37 – Deterioration and rot of several rafters and wood bearing plates embedded within the limestone wall were observed near this leak location.

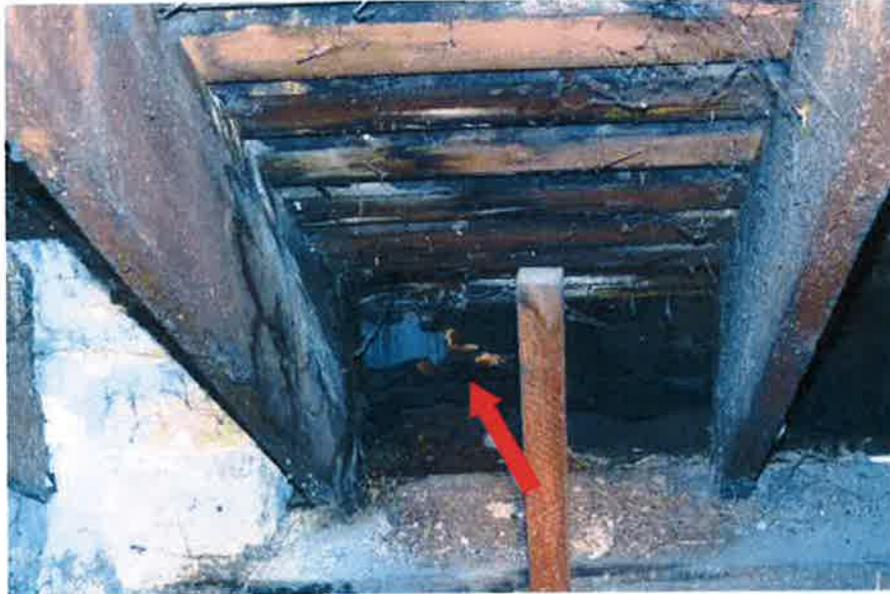
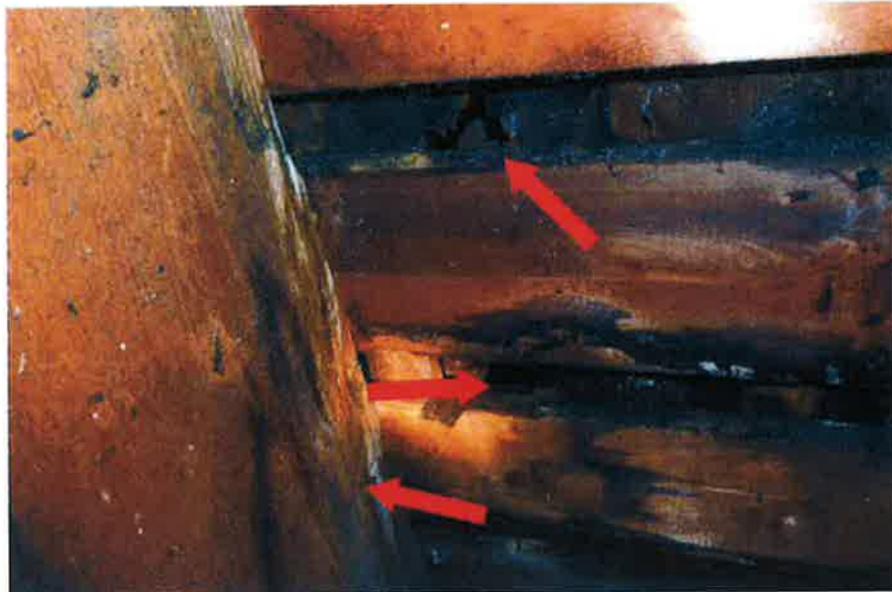
Photo 39 – Within the attic, deterioration and rot of wood fascia, roof framing components, and decking were observed near the north wall of the bell tower.

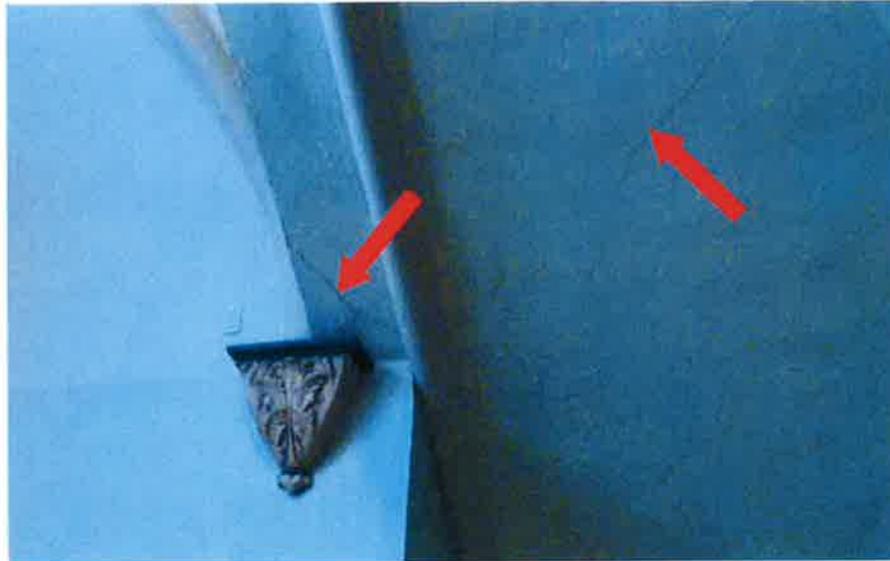
Photo 41 – The plaster ceiling below this leak location exhibited cracking.

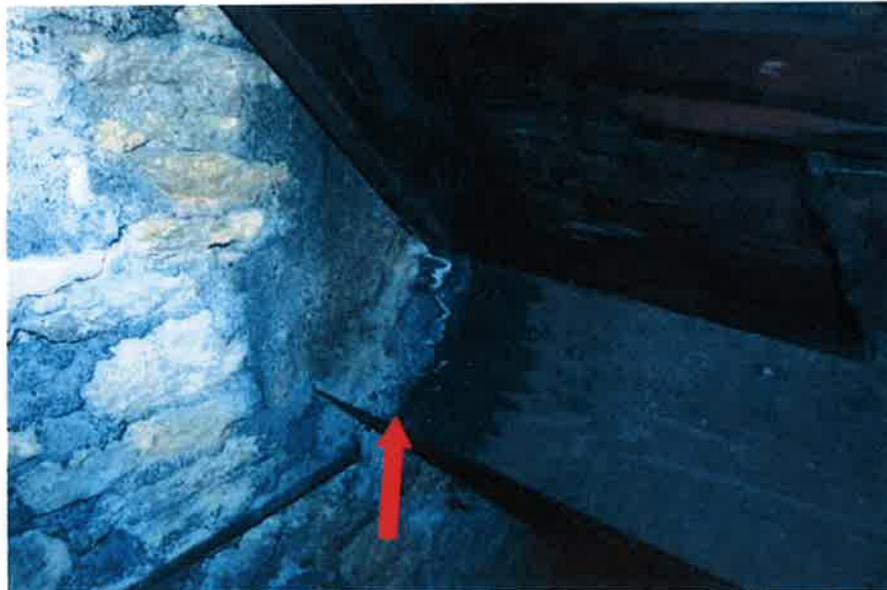
Photo 42 – Roof purlins exhibited discoloration consistent with water staining near limestone exterior walls at several locations.

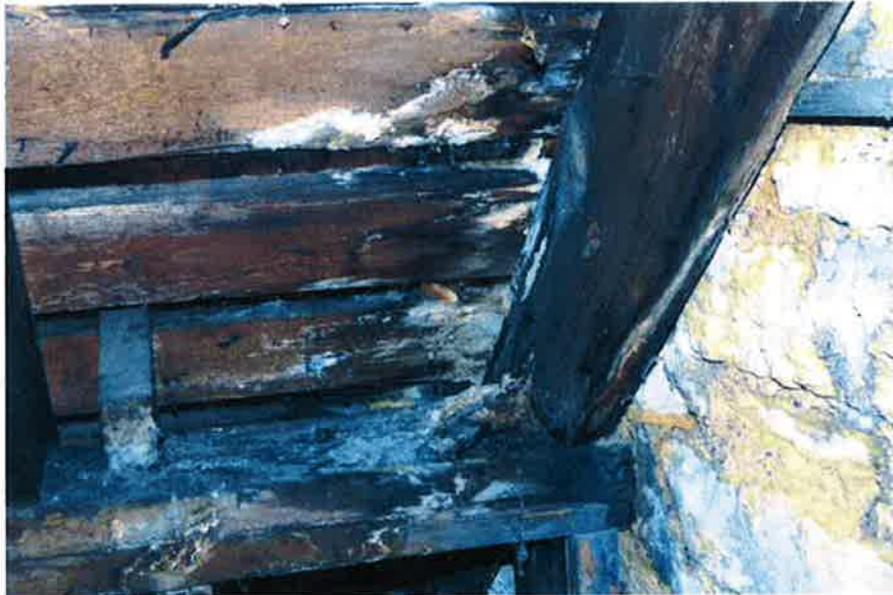
Photo 43 – Discoloration and minor deterioration of wood roof decking was observed near the south gable wall.
