HISTORIC PRESERVATION COMMISSION

March 14, 2016

Evaluation of Exterior Walls and Roofs at Batavia Park District East Side Community Center Complex

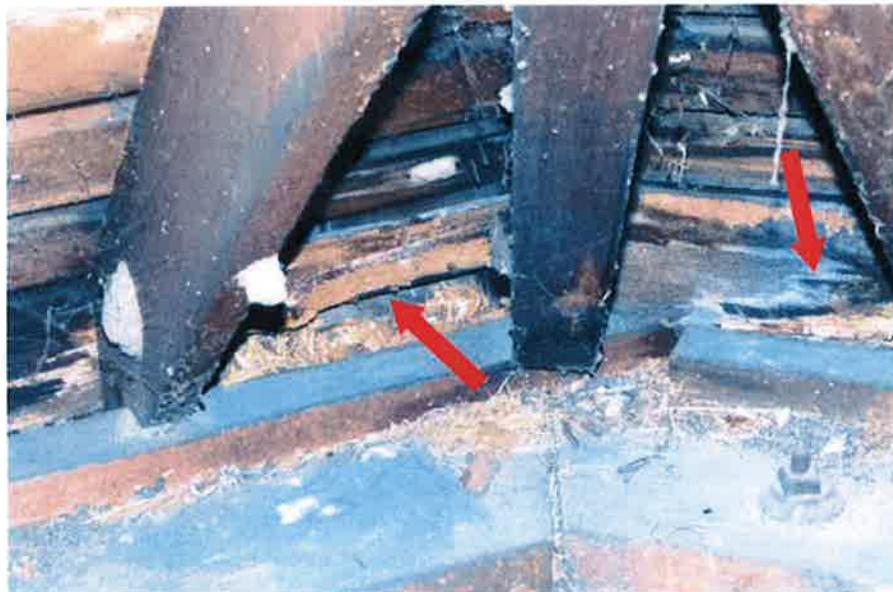
Photo 44 – Deterioration of various wood members was observed around the perimeter exterior walls of the stage on the north end of the building.

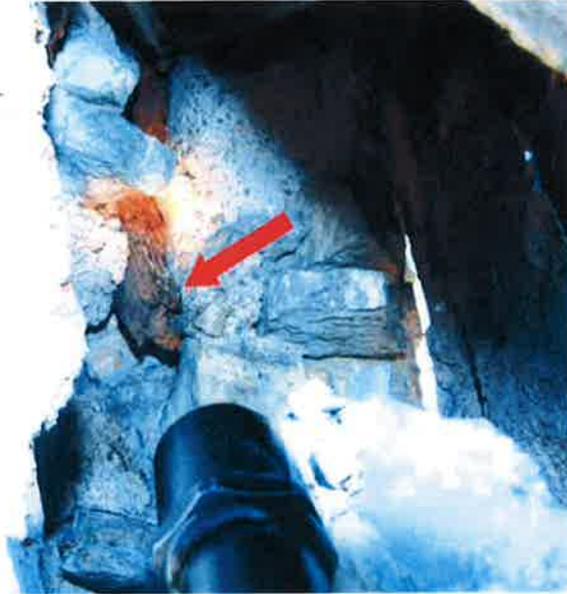
Photo 45 – At a location where a wood roof rafter was exposed on the exterior of the building, through a hole in exterior wood trim, the rafter exhibited deterioration.

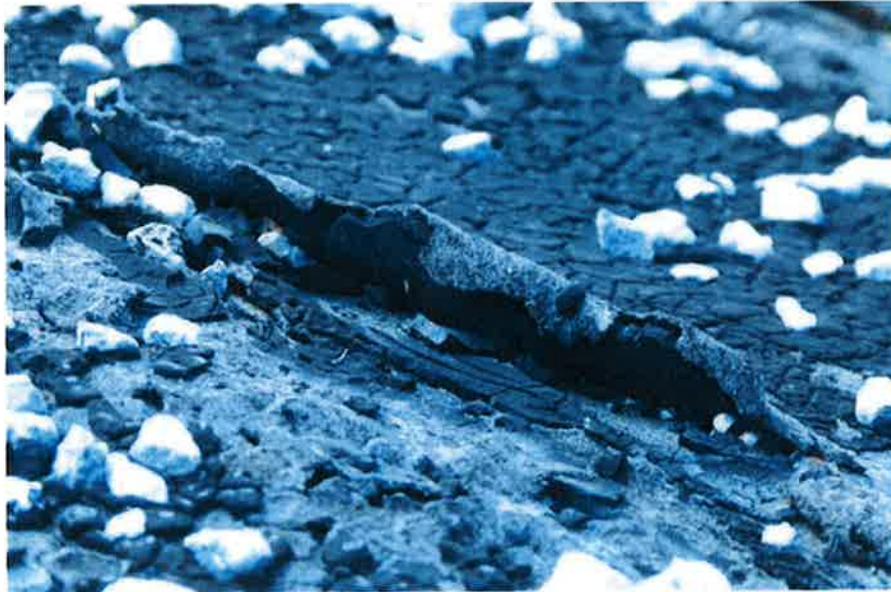
Photo 46 – The roof membrane exhibited significant deterioration and tears at several locations.
