HISTORIC PRESERVATION COMMISSION

March 14, 2016

Evaluation of Exterior Walls and Roofs at Batavia Park District East Side Community Center Complex

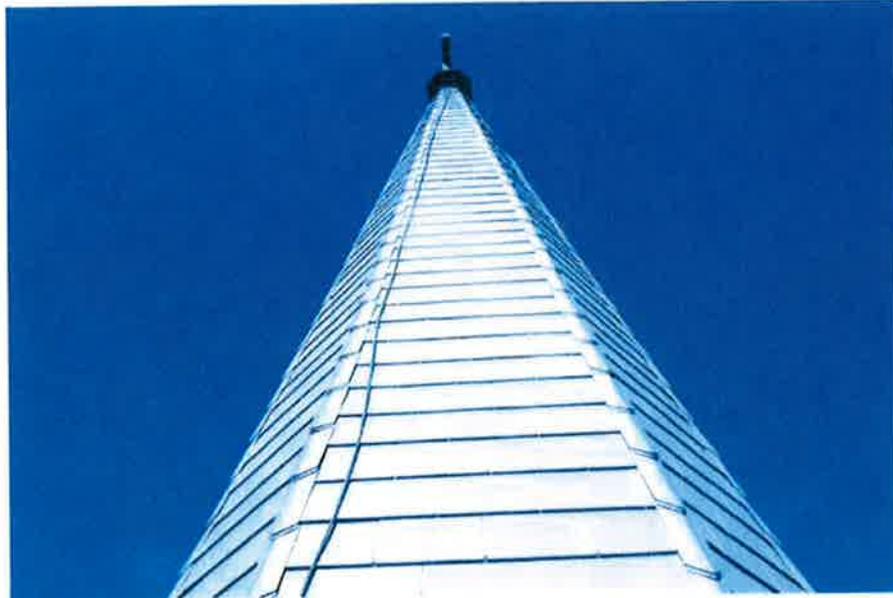
The steep-slope roofing system over the bell tower consisted of pre-finished aluminum shingles placed over existing wood shingles and wood plank decking (Photo 11). It did not appear that a waterproof or water-resistant underlayment had been included in the roofing system. However, this could not be confirmed.

Photo 11 – The steep-slope roofing system over the bell tower consisted of pre-finished aluminum shingles placed over existing wood shingles and wood plank decking.

- D. Repair or replace exposed copper flashing, gutters and downspouts. All new copper work will match the original profiles and ornamentation.
 - E. Minor repairs to the existing bell tower roof.

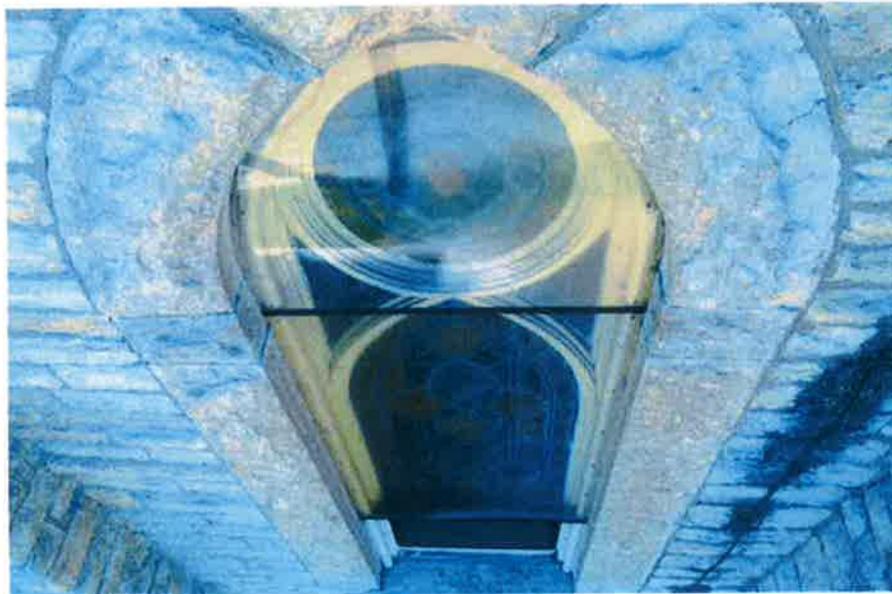
5. Deterioration of wood window frames, door frames, louvers, and fascia trim was observed at many locations throughout the building (Photos 29 through 31). Most exposed wood components exhibited some degree of deterioration. At some locations, the wood framing behind the deteriorated fascia also exhibited deterioration. It should be noted that many windows had been covered with protective polycarbonate glazing² (Photo 32). However, the perimeter of the protective glazing was not watertight.

Photo 32 – many windows had been covered with protective polycarbonate glazing.
